# Report over testing of Inexa bathroom units

SBi has participated in a development project sponsored by GI concerning light bathrooms build by smaller prefabricated elements. In the project a general test program for bathrooms build by elements was developed. This test program has been used as basis for the elaboration of a test program for Inexa Bath room units made from factory made elements taking into account the specific construction and the specific materials used for Inexas elements.

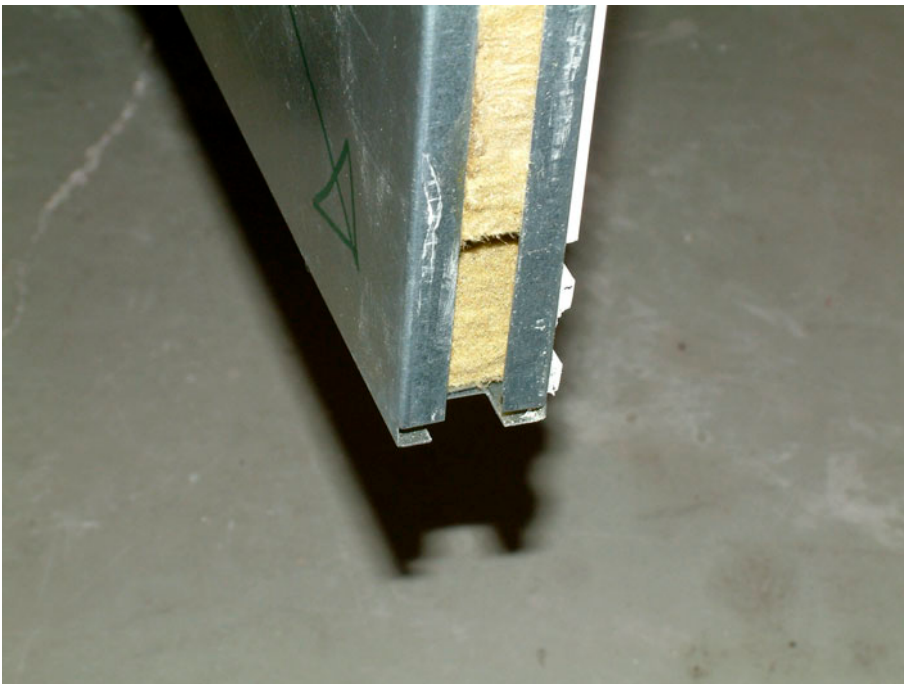
Figure 3. Corner of wall element after impact against floor.

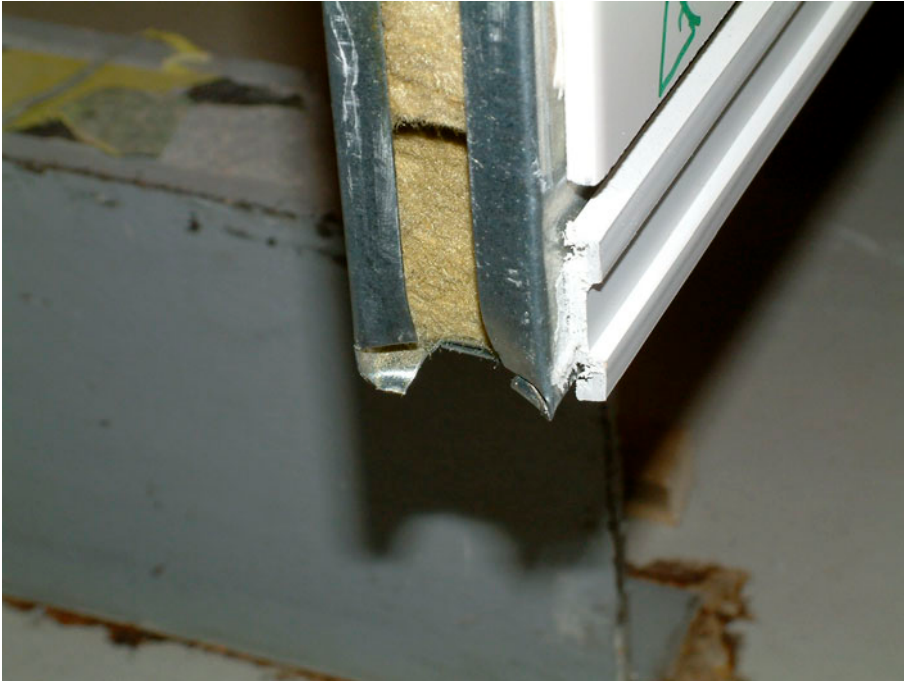
<i>Evaluation criteria</i> <i>Evaluation</i>	<p>The test must not result in damages requiring repair.</p> <p>The applied blows are assessed to be so harsh that it will only rarely occur during transport and assembling.</p> <p>The dents observed by the testing are assessed to be without significance for the function of the elements including assembling and watertightness. However, a load of a similar size as the largest one applied will require repair and consequently does not fulfil the evaluation criteria.</p>

Figure 4. Corner of wall element after dynamic impact with steel ball (10 Nm).

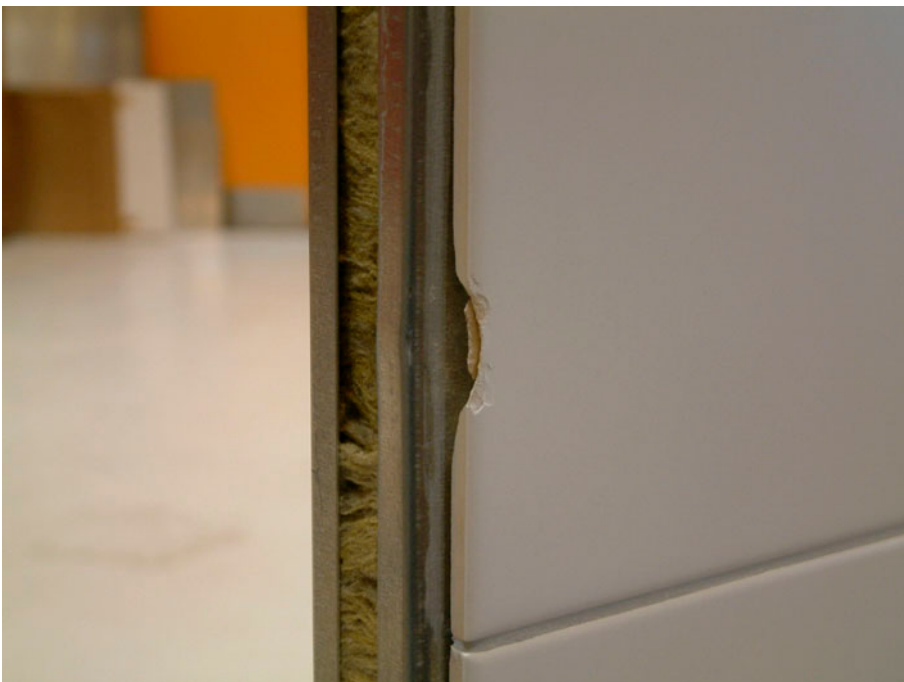
- The biggest wall element-approximately 1.2 x 2.4 m - has a mass of 66.3 kg whereas the supplied floor element- approximately 1.1 x 1.3 m - has a mass of 120.4 kg. The volume of the biggest elements may cause problems when transported in narrow places.
- By lowering the elements onto a concrete floor - simulating elements delivered with a crane - no visible damage was observed.
- Impacts with a 1 kg steel ball falling from 1020 mm (10Nm) on edge and surface respectively resulted in a dent in the surface and curling of the flange. When the steel ball fell from 1530 mm (15 Nm) it resulted in a dent in the surface and a dent and a damaged tile on the edge.

Figure 5. Tile on edge of wall element after impact from steel ball (15 Nm).

Dynamical loads under transport may under certain unfavourable conditions damage the surfaces to an extent where 1 or 2 tiles need to be changed. In such cases special adhesive and joint grout is needed and consequently it should be available in smaller amounts for repair. Other dynamic loads under transport might cause a dent in the flange of a single element. However, these dents have no influence on the performance of the element, including
